Inspection Report
Minerals Regulatory Program
November 9, 2009

Mine Name: Soma Quarry	Permit Number: S0230065
Operator Name: Nephi Sandstone Corp.	Inspection Date: November 5, 2009
Inspector(s): Wayne H. Western	Time: 5:15 PM
Other Participants: None	Mine Status: inactive

The purpose of the inspection was to determine if the overhang had been removed.

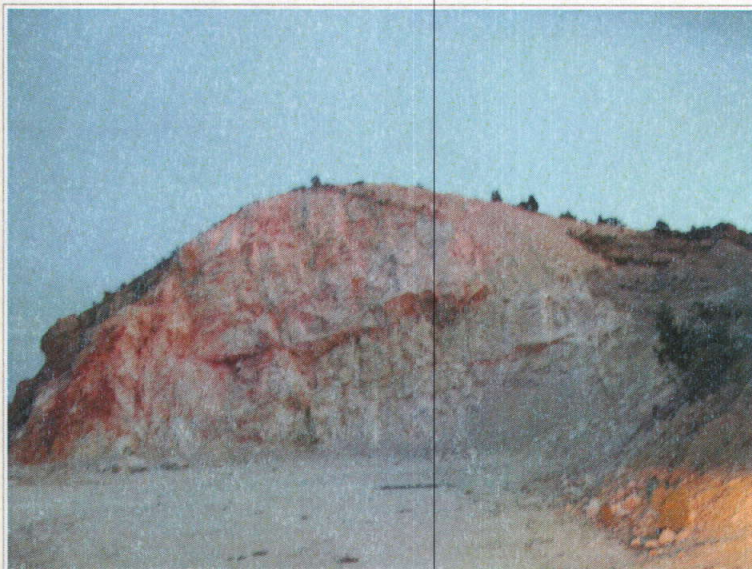
After

The Operator had removed most of the overhangs. There are still some minor overhangs. The slope needs to be reduce to no more than 45 degrees.

As part of the general mine plan, the Permittee should lay the highwall back to a 45-dregree slope or less. Continue to monitor this site when in the area.
